SUBJECT: 9/13/01 KSC Lifting Devices and Equipment Committee Meeting Minutes

RE: Crane Accident Case Study

#### POTENTIAL CYLINDER FAILURE ALERT OF MANITOWOC 777 CRANE

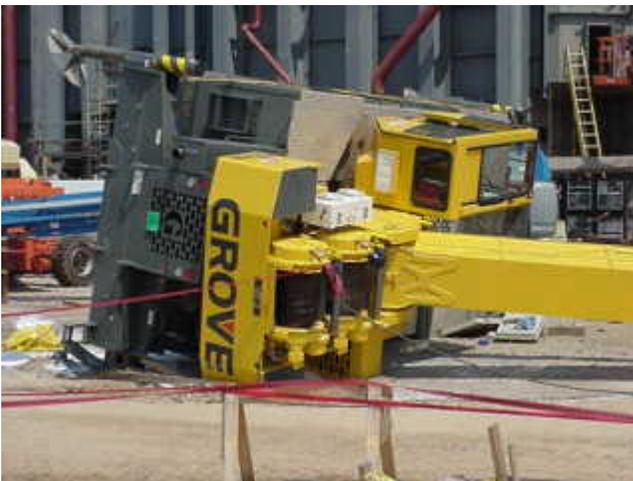
**Even without a load on the crane, it still tipped over. Outriggers must be fully extended out when the crane is in use.**

Looking at back of crane. Red tape attached to a saw horse on our site. Not outriggers down but not extended.

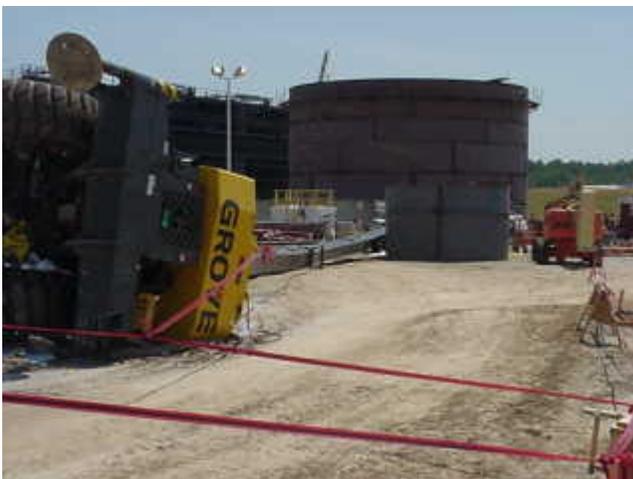
Looking down boom from back of crane. Saw horses delineating our site border.

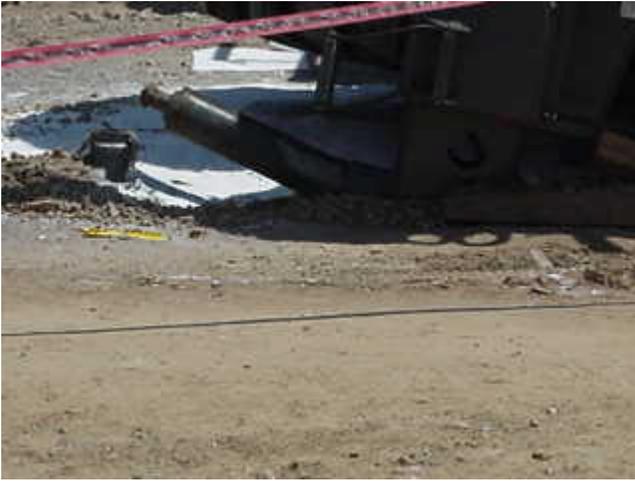
Bent outrigger with base plate still in the ground.

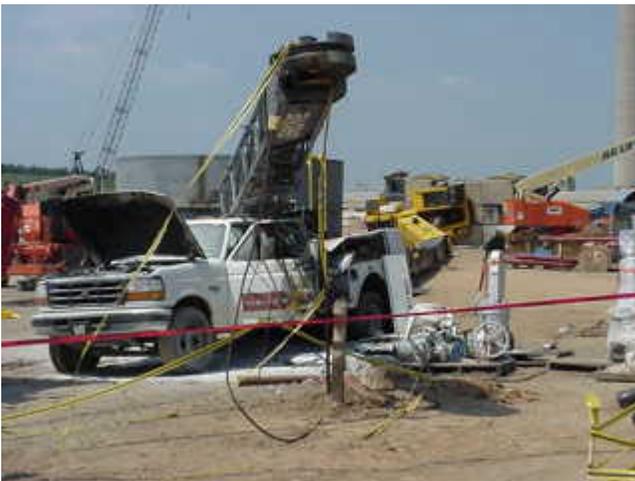
Looking up the crane boom from truck to crane.

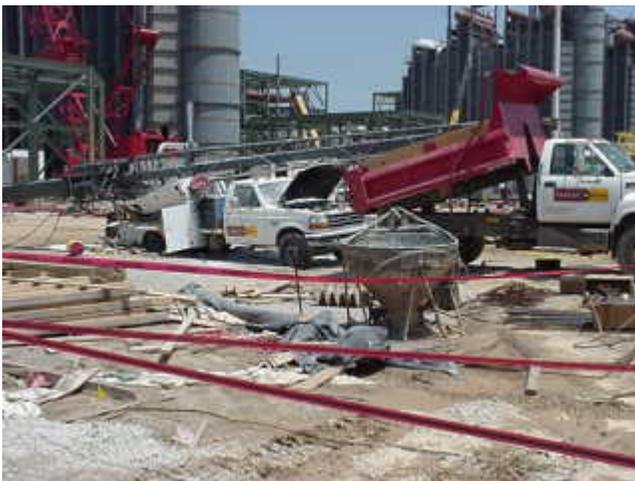
Looking at truck from the East.

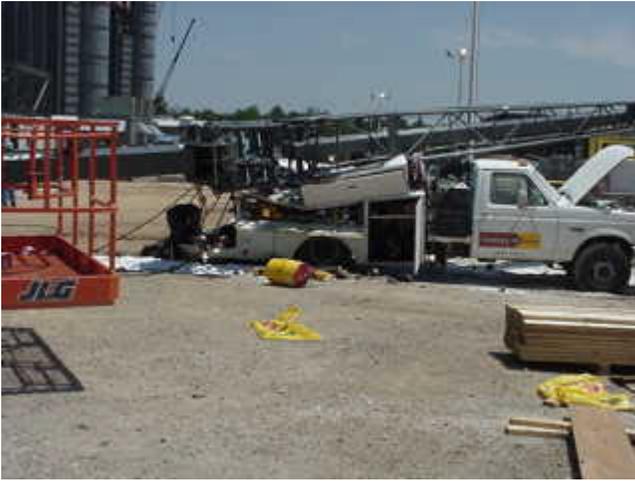
View of the truck with the crane boom on it. The impact blew the rear suspension on the truck.

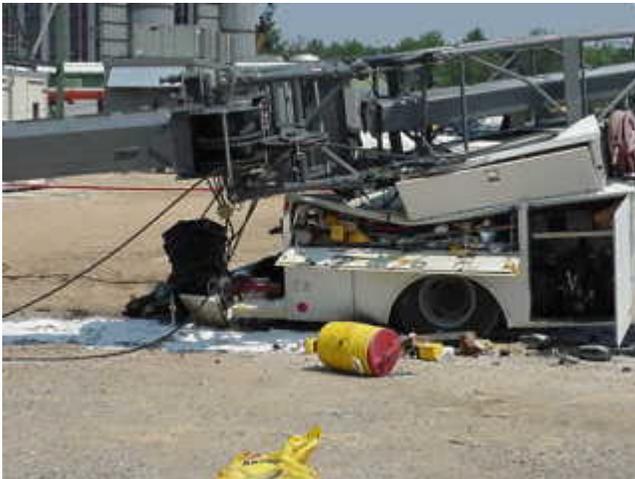
Close up of the back of the truck where the mechanic was and the rigging ball.
